Service Bulletin 19

(a) Service Bulletin No.:	SB19
(b) Revision / Date	0/13 August 2010
(b) Title:	Thunder & Colt Adjustable Height Burner Frames
(c) Description:	Inspection of Dowel Pins
(d) Applicability:	EASA.BA.012, EASA.BA.013
(e) Effectivity:	Burner Frame Part Numbers CB8811 (A0/BFSA/800/A), CB8813 (A0/BFSA/803/A), CB8821 (A0/BFSA/501/A), CB8823 (A3/BFMA/601/A), CB8825 (A3/BFMA/602/A), CB8903. <i>This SB only applies to adjustable height burner frames with dowel pins and grub screws not the later types fitted with bolts (see Section 10 of this document).</i>

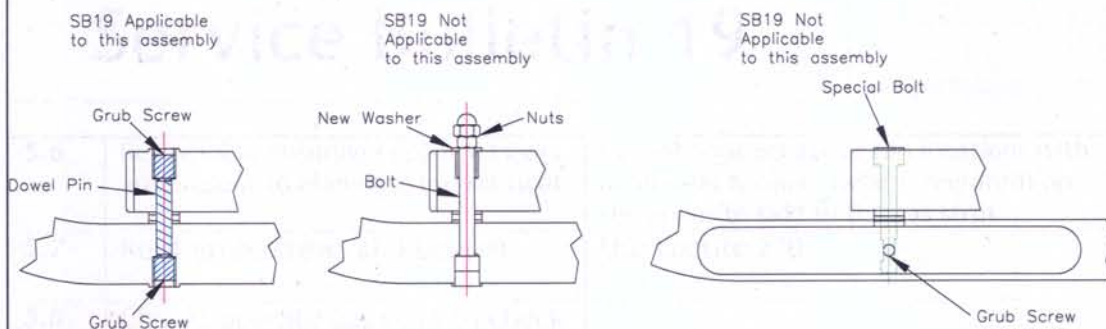
10. Additional Information: Identification guide

2. Background: A dowel pin has failed in service. Subsequent investigation suggests that the failure could be due to abnormal loading caused by distortion of the inner frame. This SB only applies to adjustable height burner frames with dowel pins and grub screws not the later types fitted with bolts (see Section 10 of this document).
