# Service Bulletin 32

(a) Service Bulletin No:	32
(b) Revision / Date	4 / 03 November 2021
(c) Title:	Quick Shut Off Valves on Duplex propane cylinders CB2901, CB2902, CB2903.

(d) Description:	<p>Undersize CB437 flanged adaptors for Quick Shut-Off valves.</p> <p>Stainless Steel Cylinders CB426, CB497, CB599, CB959, CB2088, V20, V30, V40; Titanium cylinders CB2380, CB2383, CB2385, CB2387, T30 (CY-050-A-001 and "Worthington" Aluminium Cylinders CB250 may also be affected if fitted with CB437 flanged adaptors supplied on invoice numbers listed in section (f)</p>

SB32 Cylinder Torque Test  
& Rectification Action

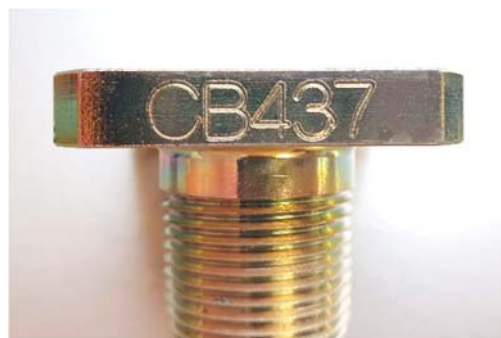
Affected Flanged Adaptors can be alternatively identified by the presence machine engraved part numbers. Below is an example of an affected machine engraved Flanged Adaptor:

Figure 1 - Machine Engraved Flanged Adaptor

Affected Flanged Adaptors were released into service from the 18 January 2019. Flanged Adaptors supplied before this date are not affected.

Final rectification action must be applied to all affected cylinders before 31/01/2022. Rectification action requires the replacement of the Flanged Adaptor with either a CB437 adaptor at Issue H or later, or by replacing the QSO valve assembly with a handwheel valve part No CB0824-0001 (this part has a Rego-type hose connection).

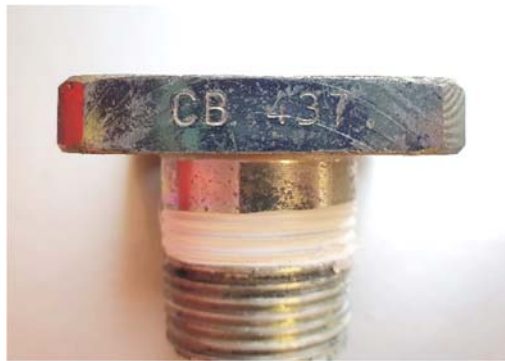
The above machined engraving must not be confused with hand stamped part numbering. Flanged Adaptors identified with hand stamped markings are unaffected. Below is an example of an unaffected hand stamped Flanged Adaptor:

*Figure 2 - Hand Stamped Flanged Adaptor*

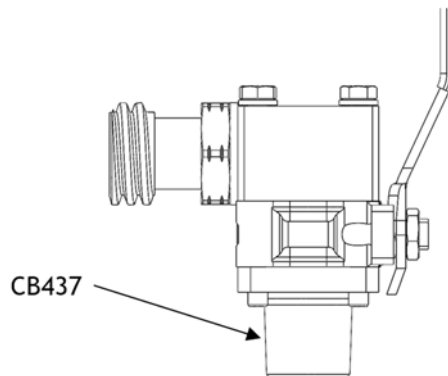
Two batches of CB437 Flanged Adaptors for Quick Shut-Off (QSO) valves have been supplied with undersized threads.

When the minimum sized adaptors are combined with cylinder bosses at maximum tolerance dimension the thread can bottom out in the cylinder boss. Although the required installation torque values can be achieved the unscrewing torque may be undesirably low. In extreme cases the adaptor may be unscrewed by hand.

This condition, if not detected and corrected, could result in an uncontrolled release of liquid propane which in turn could result in a fire hazard that could damage the balloon and its envelope, ultimately leading to a forced emergency landing, during which balloon occupants and persons on the ground could be injured.

Affected cylinders are prohibited from further flight.

Affected cylinders must be checked for leaking around the interface between the QSO valve Flanged Adaptor and the cylinder boss using leak detector fluid within 24 hours of receipt of this bulletin. Any cylinders found to be leaking should be emptied of fuel immediately. A pilot may carry out this inspection. A satisfactory leak check **does not** release the cylinder to service.

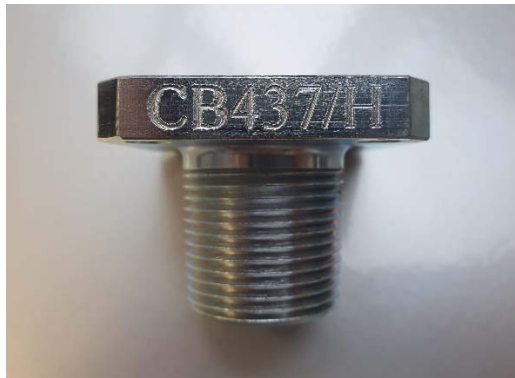
Figure 3 - Replacement Flanged Adaptor

Replacement Flanged Adaptors are marked with the drawing number and issue (CB437/H) and are available by contacting [aftersales@cameronballoons.co.uk](mailto:aftersales@cameronballoons.co.uk).

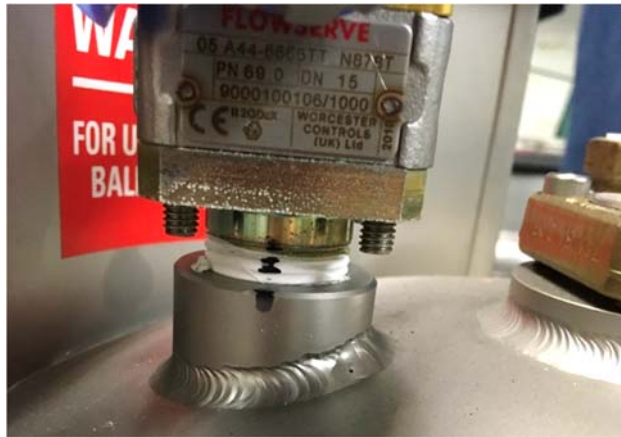
Figure 1 - Alignment marking on thread and boss

3. Make an alignment mark on the thread of the Flanged Adaptor and the cylinder boss to assist in observing rotation.

4. Fit the Flanged Adaptor installation tool onto the Flanged Adaptor. Smoothly and progressively apply a torque of up to 90Nm with the Torque Wrench. Do not jerk the wrench or the set torque may be exceeded.
5. If the Flanged Adaptor rotates the cylinder has failed the Torque Test and must be removed from service.
6. If the Flanged Adaptor does not rotate re-assemble the QSO assembly onto the flange and perform a Pneumatic Leak Test on the cylinder [HAB Maintenance Manual Supplement 7.52].
7. If the cylinder passes both the Torque Test and the Pneumatic Leak Test, then it may be released to service. Make a log-book entry or complete other release paperwork (e.g. Form 1) See section 3.

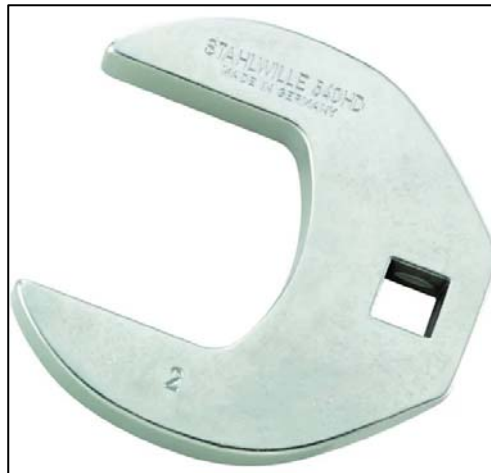
Figure 2 - 'Crow's Foot' Spanner

NOTE: Use of a 'Crow's Foot' adaptor requires an adjustment factor to be calculated for the torque wrench, see Appendix A. If the torque wrench is held at 90° to the centreline of the 'Crow's Foot' no adjustment factor is required. 90° to the centreline of the 'Crow's Foot' is a good orientation for the 'Crow's Foot' in this application.
