**CAMERON BALLOONS LTD (THUNDER & COLT)  
SERVICE BULLETIN: ENVELOPES SB3**

**Subject: THUNDER AND COLT  
TRIVENTS**

**Title: Reinforcement of attachments on the Trivent flap.**

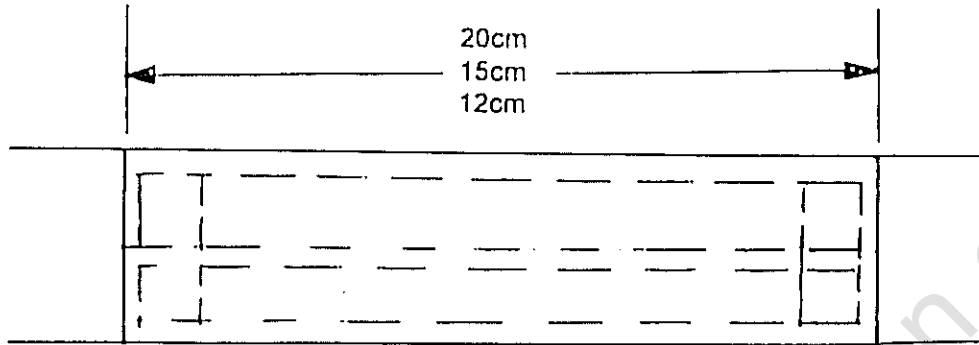
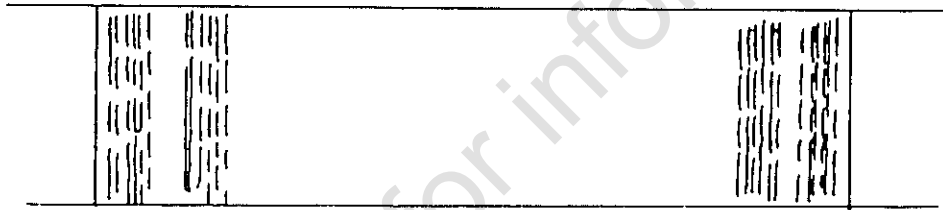
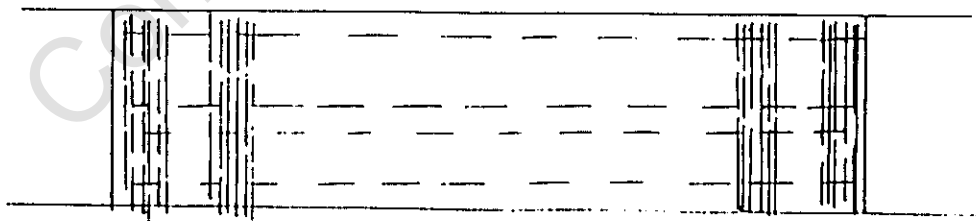
Fig 1 Twin-needle Box stitching Pattern

Then add 6 rows of stitching at each end.

Finished Stitch Pattern.

1. The ends of stitch lines must always be "locked" by overlapping or back tacking to prevent the new seam from pulling apart.
2. The cut ends of the load tape should be sealed with a flame or hot knife in order to prevent fraying.
3. The stitch pattern for all the reinforcements is detailed in Figure 1.
