# Service Bulletin 24

(b) Title:	Sirocco Double Burner, Mounting Bracket Failure
(c) Description:	Inspection / Replacement of gimbal mounting bracket
(d) Applicability:	Manufacturers: <b>Altisph'air, Ballons Libert sprl, Ballonservice &amp; Technik, Balóny Kubíček spol. s.r.o.,</b> Cameron Balloons Ltd., Lindstrand Hot Air Balloons Ltd., Llopis Balloons, Schroeder Fire Balloons GmbH, Ultramagic S.A.  TCDS Numbers: Austria BA 009-ACG, United Kingdom (UK) BB5, UK BB19, UK BB20, UK BB25, EASA.BA.001, EASA.BA.002, EASA.BA.003, EASA.BA.004, EASA.BA.012, EASA.BA.013, EASA.BA.014, EASA.BA.015, EASA.BA.016, EASA.BA.017, EASA.BA.021, EASA.BA.120, EASA.BA.501, EASA.BA.502, EASA.BA.503, EASA.BA.504, EASA.BA.505, EASA.BA.506, EASA.BA.517 and France No.186.  Burner Assembly Part Numbers: CB2691, CB2694, CB2695, CB2698, CB2699, CB 2700, CB2702.

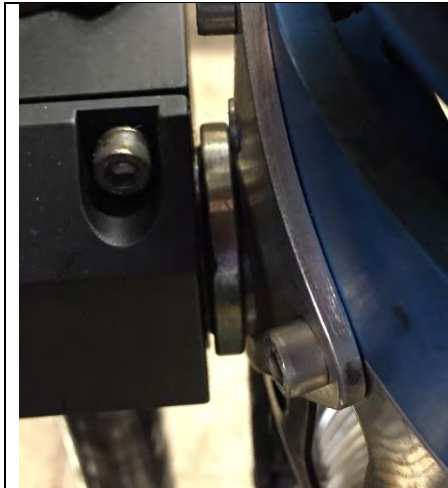
Fig 1.1: CB2723-Issue A to D  
Original Bracket (no external  
weld)

**Replacement of burner bracket with latest standard (CB2723-Issue E or later) at owner's convenience (recommended). The latest standard of bracket can be identified by visible welds between the central bobbin and the brackets (see Appendix 1)**

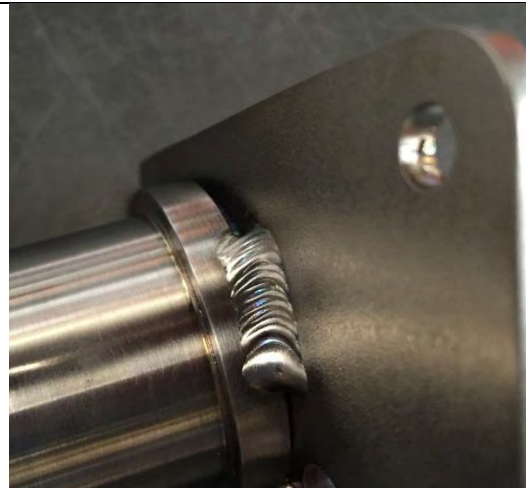
Fig 1.2: CB2723-Issue E  
Modified Bracket (additional external  
weld visible)
