Service Bulletin 28

(a) Service Bulletin No:	28
(b) Revision / Date	0 / 15-January-2020
(c) Title:	Stratus Double Burner, Burner Hanger Inspection
(d) Description:	Inspection / Replacement of Stratus Double Burner Hanger.

SB28: Accomplishment Instructions.
Stratus Double Burner; Mounting Hanger Inspection.

CBL/TN/DCB/3191

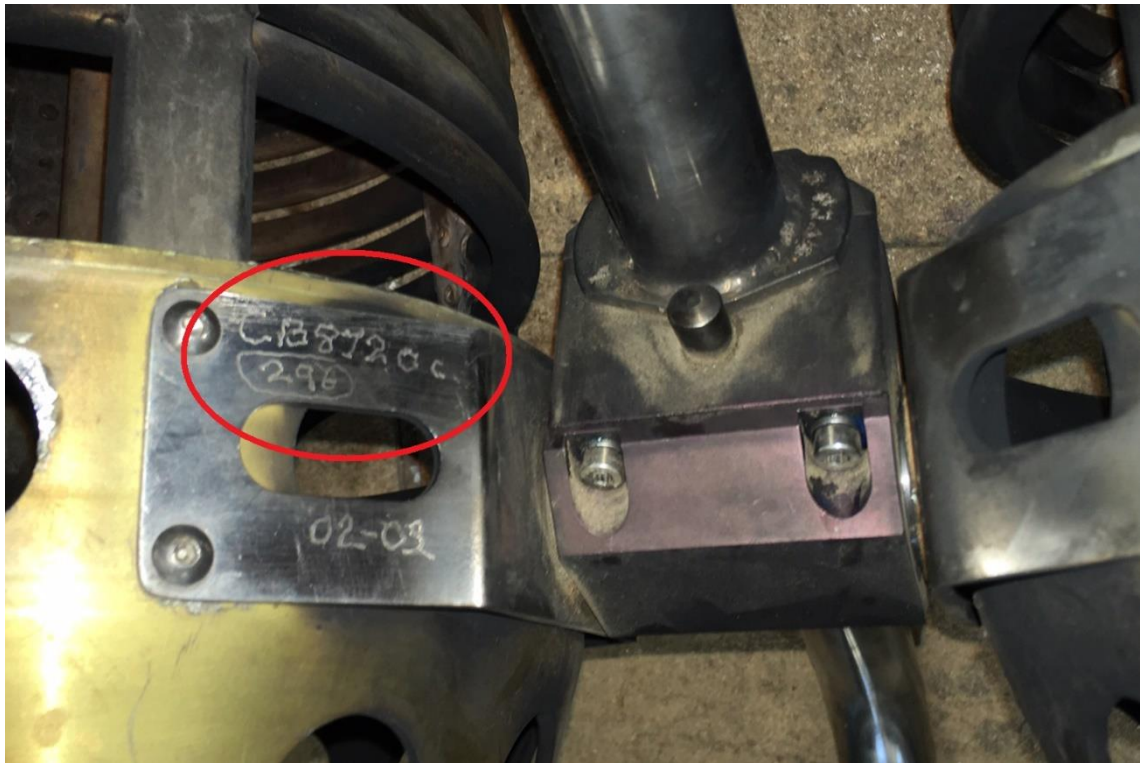
- 2.1.1 The affected hangers were fitted to double burners with serial numbers 320 or lower. The burner serial number is hand engraved onto one of the hanger end plates. Should the burner serial number be unreadable or missing Cameron Balloons can identify the burner from the manifold block serial numbers (machine engraved onto the upper surface of the burner manifold block).

Fig 3. Burner Serial Number (296) & Part Number (CB8720) engraved on the hanger

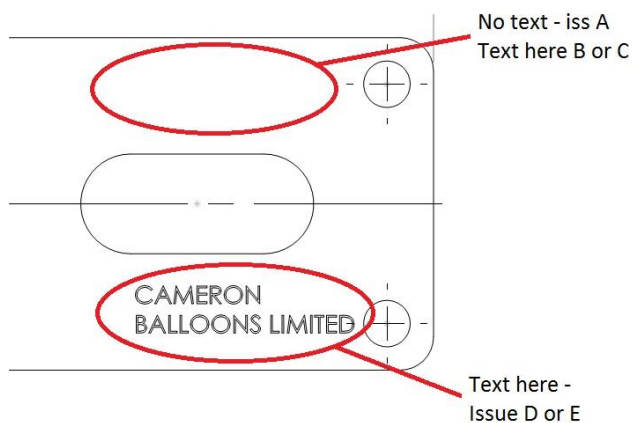
2.1.2 Affected hangers (Issues A through C) have either no machine engraving or have “Cameron Balloons Limited” machine engraved in the upper right-hand corner of the end plate. Non-affected hangers (Issue D and E) have the text “Cameron Balloons Limited” machine engraved in the lower right-hand corner of the end plate.

Fig 5. Position of Machine Engraving.
