Alert Service Bulletin No 33

(a) No.:	33
(b) Revision / Date	1 / 16 May 2022
(c) Title:	ALUGAS Cylinders - Temporary withdrawal from service
(d) Description:	Temporary withdrawal from service of CB2990 (Alugas) cylinders
(e) Applicability:	All hot-air balloons (from all manufacturers) fitted with CB2990 (Alugas) cylinders
(f) Effectivity:	Fuel cylinders Part Number CB2990 (Alugas) cylinders having serial numbers: OC25001 to OC25202 QI14001 to QI14494 Note: This serial number range covers all CB2990 (Alugas) cylinders currently in service. These fuel cylinders are known to be installed on, but not limited to, hot-air balloons and airships manufactured by Cameron Balloons Ltd, Colt Balloons, Lindstrand Balloons Ltd (LBL), Lindstrand Hot Air Balloons Ltd, Sky Balloons, Thunder Balloons, and Thunder & Colt

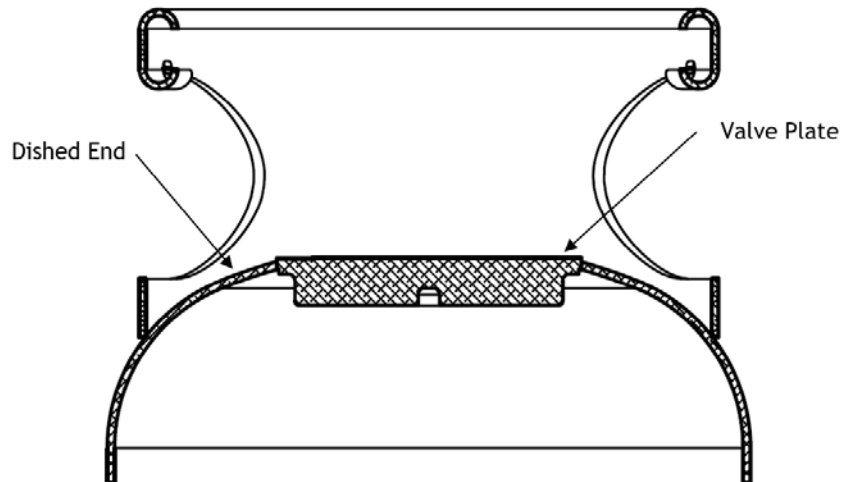
Figure 1 - Section indicating Valve Plate

Five CB2990 (Alugas) cylinders have developed cracks in the weld between the cylinder valve plate and the upper dished end. These cracks allow the release of propane from the cylinder. Failures have been observed during periodic inspection (hydraulic pressure test), and leak test. All the in-service failures seen to date have been from the batch of cylinders with serial numbers starting OC.

Within 24 hours of receipt of this bulletin affected cylinders must be checked for leaking around the interface between the cylinder valve plate and the upper dished end using leak detector fluid. Any cylinders found to be leaking must be emptied of fuel immediately. A pilot may carry out this inspection. A satisfactory leak check **does not** release the cylinder to service.
