LINDSTRAND BALLOONS LTD

SERVICE BULLETIN No 6

ISSUE 1 – DATED 24-8-99

Title: BURNER VALVE REPAIR

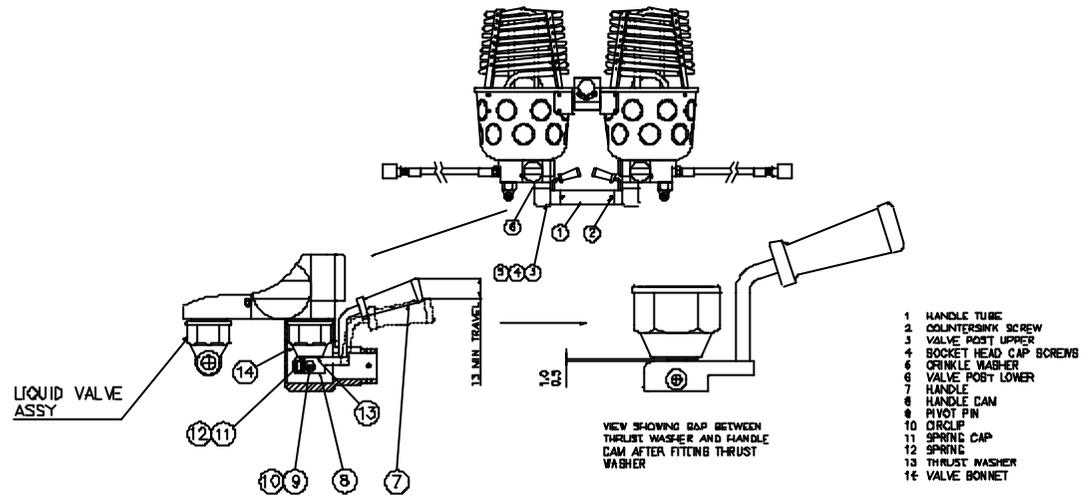
FIG 2. JETSTREAM SERIES 2 BURNER SQUEEZE ACTION MODE

Background: The main and liquid fire blast valves used on the Jetstream Series 2 burner have, in certain installations, been unable to switch off the fuel flow, causing the flame from the liquid fire jet or the coil jet ring to continue burning after the valve has been closed. Investigation has shown this problem to be caused by oversized thrust washers being fitted.

- 2 Using a 150 mm (6") steel rule, measure the valve handle travel i.e. the amount of handle travel available before the valve cam touches the plastic thrust washer. The correct amount of travel may be gauged by reference to figures 1 and 2. This check must be carried out on all main and liquid fire valves and for both toggle action and squeeze action style valves.

- 10 Select the new thrust washer from the two supplied to give a clearance between the valve handle cam and the plastic thrust washer of between 0.5mm and 1mm (see figure 2). Note the thrust washer thicknesses as follows:

Thrust washer type BU-008-A-050-A	2.5mm thick
Thrust washer type BU-008-A-050-F	2.0mm thick
- 11 Align the holes in the handle cam with the hole in the valve spindle and replace the pivot pin.
- 12 Fit a new circlip to the pivot pin using a pair of external circlip pliers.
- 13 Using a set of feeler gauges, check that the clearance between the valve handle cam and the thrust washer is between 0.5mm and 1mm as shown on figure 2.
- 14 Place the lower and upper valve posts in position and fit the handle tube.
