# LINDSTRAND BALLOONS LTD

## SERVICE BULLETIN NO. 4

ISSUE 2 - DATED 12.03.98

<u>Title:</u>	MULTI-BURNER GIMBAL BLOCK
<u>Classification:</u>	Recommended
<u>Applicability:</u>	Jetstream Double + CLF, Jetstream Triple, Jetstream Triple + CLF, Jetstream Quad Burners.
<u>Serial Numbers Affected:</u>	019, 018, 028, 041, 070, 066, W/O 1129/1130, 165, 082, 101, 090, 074, 094, 090, 100, 135, 095, 188, 171, 190, 197, w/o 1808, 200, 249, 250, 297, 298, 307, w/o 3312, 311 312, 325, 235, 326, 334, 336, 300, 335, 345, 350, 358, w/o 3711, 377, 372, 378, 387, w/o 3724, 391, 326, 304, 409, 412, 413, w/o 14314, 421,317, 427, 431, 439, 445, 446, 447.
<u>Compliance Standard:</u>	Inspection to be achieved within the next 10 hours flying time.
<u>Background:</u>	The gimbal block shown in Fig SB4-001 and used on all the above burner types is designed to allow variable friction, independently on each gimbal axes by adjustment of four socket head cap screws on each axes. In one installation, sufficient friction could not be achieved due to the two faces of the block meeting. Subsequent adjustment of the four cap screws or weakening of the central block section has caused thread failure within the centra

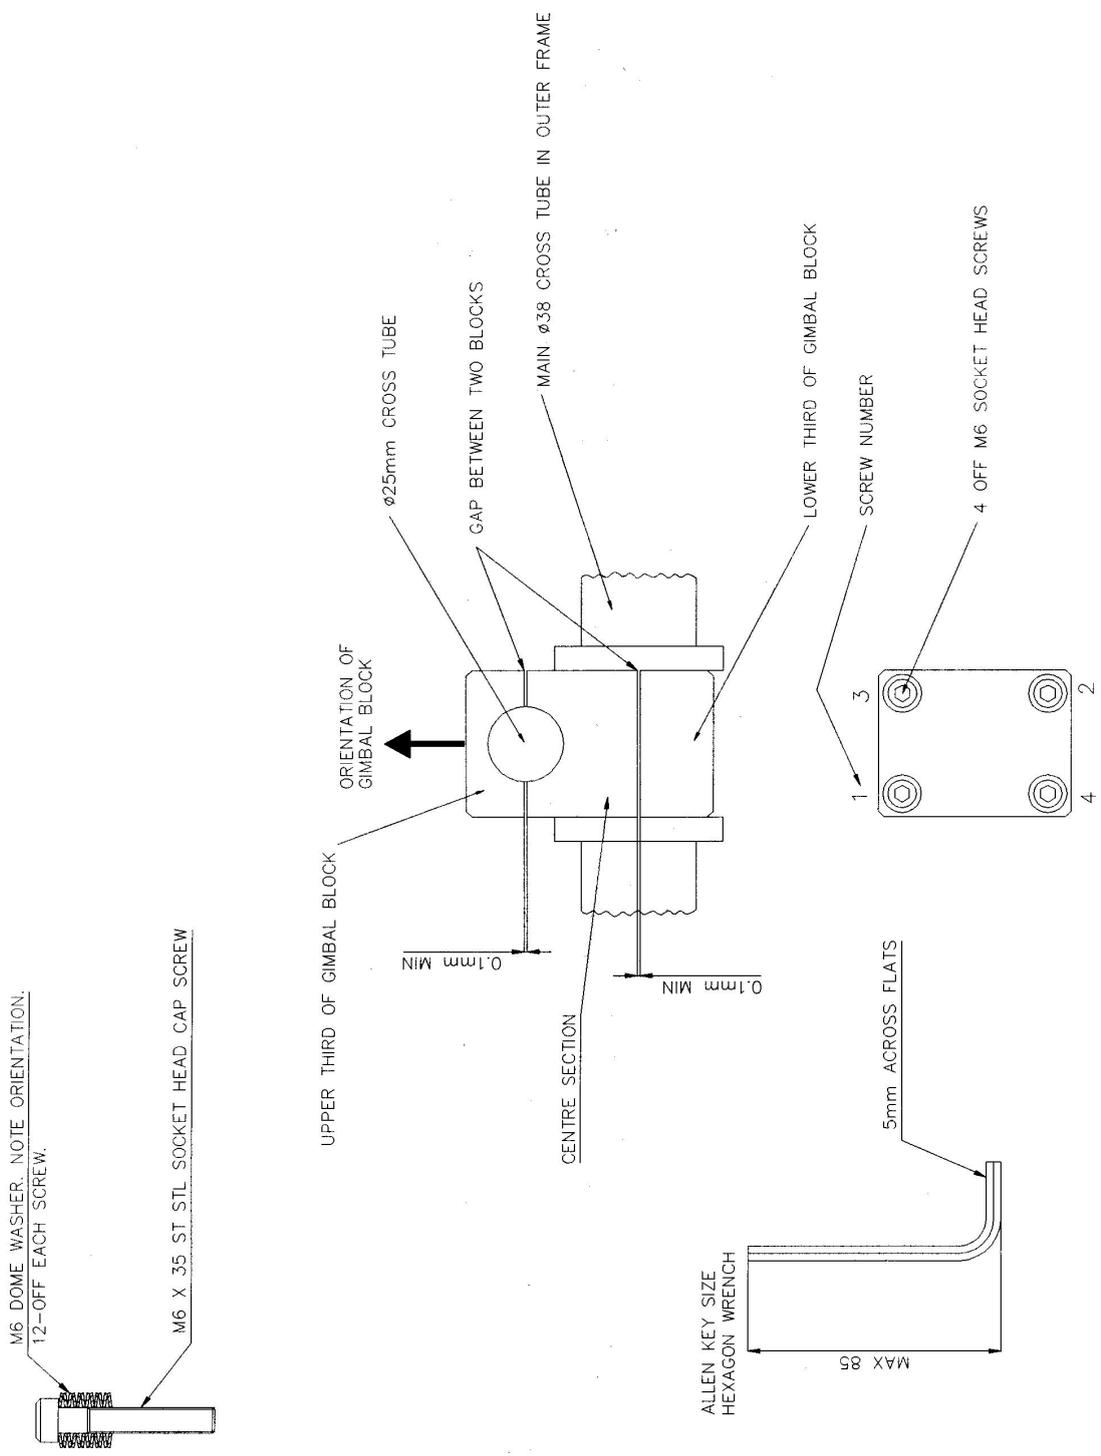
FIG SB4-002. ORIENTATION OF GIMBAL BLOCK

Both sides of the same gap should be equal and not less than those specified on Figure SB4-002. If the gaps are not equal, implement the procedure below.

If both sides of either gap are equal and less than those specified on Figure SB4-002, then a new gimbal assembly must be fitted. In this case, contact Lindstrand Balloons Ltd immediately.

Each side of the gap between the upper third of the gimbal block and the gimbal centre section should be equal and greater than the dimension specified on Figure SB4-002. Similarly, each side of the gap between the lower third of the gimbal block and the gimbal centre section should be equal and greater than the dimension specified on Figure SB4-002.

If after measurement, either of the gaps are less than those specified on Figure SB4-002, then a new gimbal assembly must be fitted. In this case, contact Lindstrand Balloons Ltd immediately.

1. Identify the screws securing the gimbal end cap to the centre section about the 25 mm cross tube.
2. Referring to Figure SB4-002:

Remove screw no. 1 using a 5 mm across flats Allen key (hexagon wrench), no bigger than that shown on the figure.

3. Apply Loctite 222 thread adhesive sparingly to the screw thread between 3 mm and 6 mm from the threaded end.
4. Ensure that the dome washers are assembled within the counter-bored hole of the gimbal block end cap, or over the screw, in the order shown on the figure.
5. Replace the screw in the hole and re-tighten using the allen key, until the screw is just nipped up.
6. Remove screw no. 2 using the allen key and repeat steps 3 through 5 inclusive.
7. Remove screw no. 3 using the allen key and repeat steps 3 through 5 inclusive.
8. Remove screw no. 4 using the allen key and repeat steps 3 through 5 inclusive.

9. Using the allen key, turn screw no. 1 a quarter turn. Repeat for screws no. 2, no. 3 and no. 4 in that order. Check the gimbal stiffness. Ensure that the screws are tightened in the above sequence and that both sides of the gap between the upper third of the gimbal and the gimbal centre section remain equal.

For the Jetstream Double + CLF and Jetstream Triple burners, the gimbal block centre section is pinned to the 38 mm cross tube and thus no variation in friction is possible by adjustment of the gimbal screws. Fully tighten the screws in the order 1, 2, 3, 4 (see figure). For the Jetstream Triple + CLF and the Jetstream Quad burners, the gimbal friction is variable by adjustment of the gimbal screws. Repeat steps 9 through 10 inclusive, until the required gimbal stiffness is achieved.
