Alert Service Bulletin 36

(a) No.:	36
(b) Revision / Date	2 / 03 July 2025
(c) Title:	PRV Adaptor CB8426 for Legacy Cylinders
(d) Description:	Inspection and possible replacement of adaptors in service based on pass criteria.
(e) Applicability:	All HAB TCs and Airships. All HAB Manufacturers.
(f) Effectivity:	Possible cylinders fitted with PRV adaptor CB8426. Thunder & Colt: <ul style="list-style-type: none">• V20-100-00/CB8420• 830922-1• V30-100-00/CB8430• V40-100-00/CB8440 Sky: <ul style="list-style-type: none">• A0/V30• A0/V40 Lindstrand <ul style="list-style-type: none">• V20/CY-020-A-001• V30/CY-030-A-001• V40/CY-040-A-001• T30/CY-050-A-001
Note: Applicability= All types and variants to which the change can be applied. Effectivity= Actual CN or group of CN's to which the bulletin has been/will be applied.

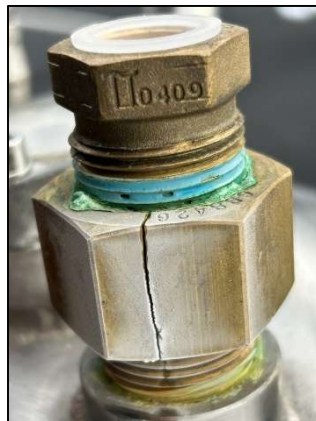
Figure 2 - Cracked CB8426, PRV Adaptor

Thirteen instances of failed CB8426 adaptors have been received since the release of Revision 1 of this Alert Service Bulletin. Failed components have presented with a crack located on the upper hex portion of the adaptor.

A number of failed adaptors have been independently assessed. The failure mode has been attributed to Stress Corrosion Cracking, caused by exposure to corrosive elements such as Sulphur, Chlorine, or Ammonia. Overtightening of the installed PRV is also likely to have exacerbated the failure mode.

Affected PRV adaptors installed in cylinders must be visually inspected for cracks within 24 hours of receipt of this bulletin, if not already undertaken following receipt of Revision 0 of this bulletin.

Final rectification action for affected cylinders requires the removal of the CB8426 adaptor and replacement with a new CB7922 adaptor. Installation of the new CB7922 adaptors must be carried out in accordance with Maintenance Manual Supplement 7.52.

Cylinders fitted with a CB8426 PRV adaptor that has cracked should be taken out of service and emptied of fuel immediately. The failure must be reported to Cameron Balloons via technical@cameronballoons.co.uk
