# Service Bulletin 32

(a) Service Bulletin No:	32
(b) Revision / Date	1 / 21 September 2021
(c) Title:	Quick Shut Off Valves on Duplex propane cylinders CB2901, CB2902, CB2903.

(d) Description:	Undersize CB437 flanged adaptors for Quick Shut-Off valves.
(e) Applicability:	All HAB TCs and AS 105 GD Airships EASA.AS.002 All HAB manufacturers

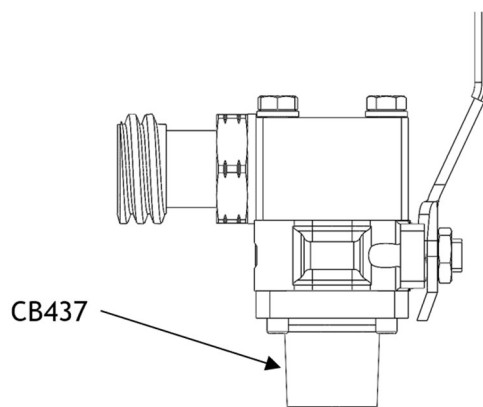
Two batches of CB437 Flanged Adaptors for Quick Shut-Off (QSO) valves have been supplied with undersized threads.

When the minimum sized adaptors are combined with cylinder bosses at maximum tolerance dimension the thread can bottom out in the cylinder boss.

Although the required installation torque values can be achieved the unscrewing torque may be undesirably low. In extreme cases the adaptor may be unscrewed by hand.

Final rectification action must be applied to all affected cylinders before 31/01/2022. Rectification action requires the replacement of the Flanged Adaptor. We anticipate that replacement Flanged Adaptors will be available by 11/10/2021. Replacement Flanged Adaptors can be identified at issue G or later. Rectification action requires the cylinder to be emptied of LPG.
