# LINDSTRAND HOT AIR BALLOONS LTD

## SERVICE BULLETIN No 9

### ISSUE 1 – DATED 24.03.05

Title: Oversize Hole Drilling for Pressure Gauge Mounting in the Burner Block.

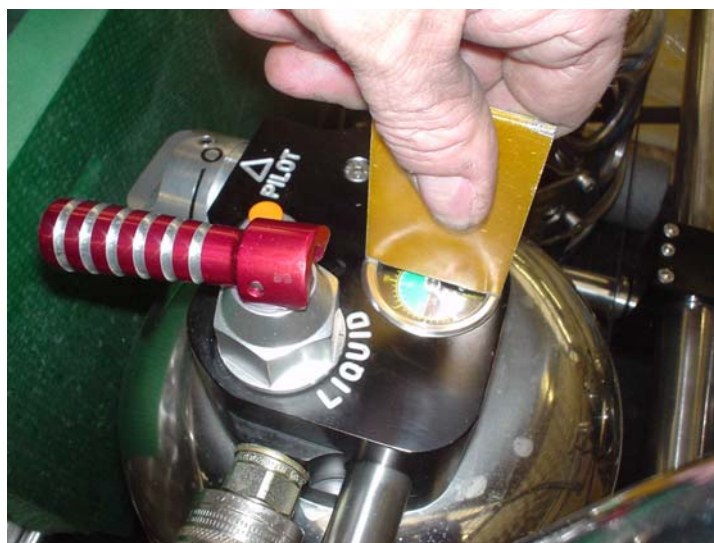
2. Remove the gauge bezel ring. Use the tool as shown in the picture below. The ring will undo in the anti-clockwise direction in the same manner as an ordinary screw thread.

- A bezel ring removal tool (LL0998). If the tool is not available, any suitable piece of material that engages in the 2 slots in the bezel ring should suffice (See picture below).

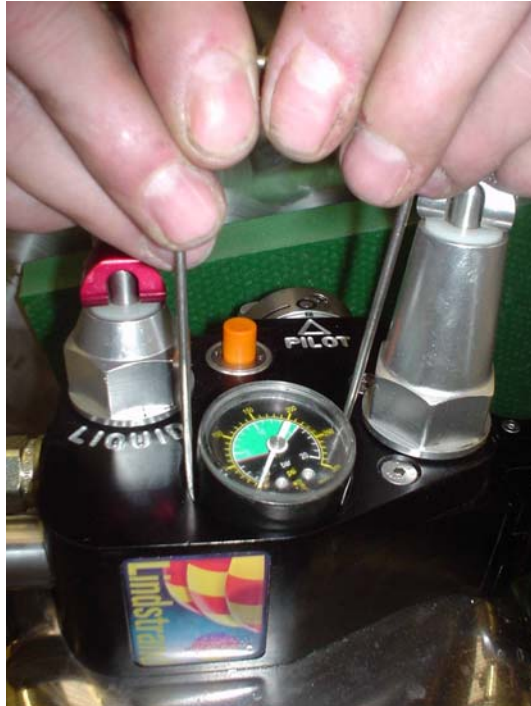
3. Use the Pressure gauge removal tool by pushing the small hooks down opposite sides of the gauge, then turn through 90° under the gauge bottom and pull the gauge out of the block. See picture below, if the burner is the opposite way up the gauge may fall out without the tools being necessary.

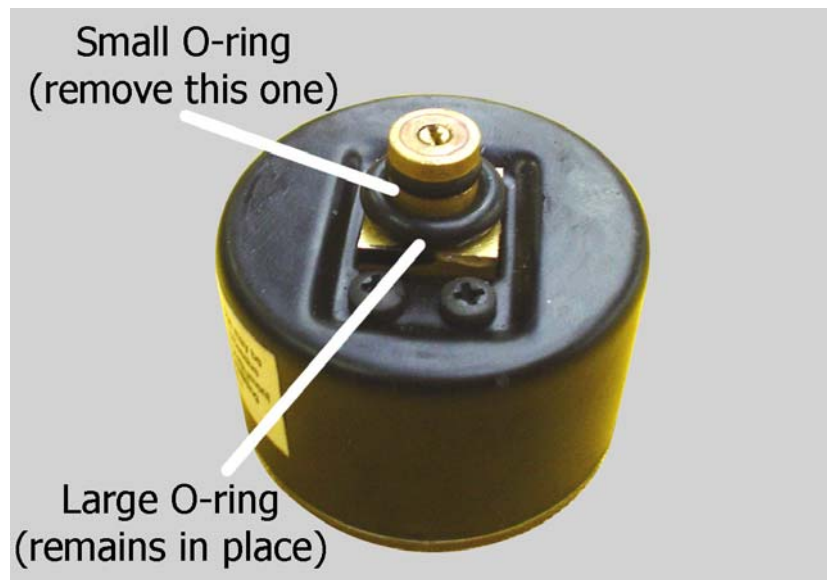
4. When the gauge is removed you should see two different O-rings on the underside as shown below;

The smaller O-ring that sits in the groove needs to be removed and replaced. This can be achieved by careful use of a sharp blade, or by using a sharp point. *It is important that the brass groove is not damaged during this process, as gouges and scratches will prevent a good sea from being achieved.*

5. With the gauge removed, take the new replacement O-ring and give it a very light coating of silicone grease. Carefully roll the new O-ring onto the pressure gauge so that it sits into the groove. Avoid splitting or damaging the O-ring.
